The Preservation of a Historic Black Farm: Matt Gardner Homestead in Giles
County, Tennessee.

A Master's Thesis Submitted to The Department of History in Partial Fulfilment
of the Requirements for the Degree of Master of Arts of Public History

Middle Tennessee State University

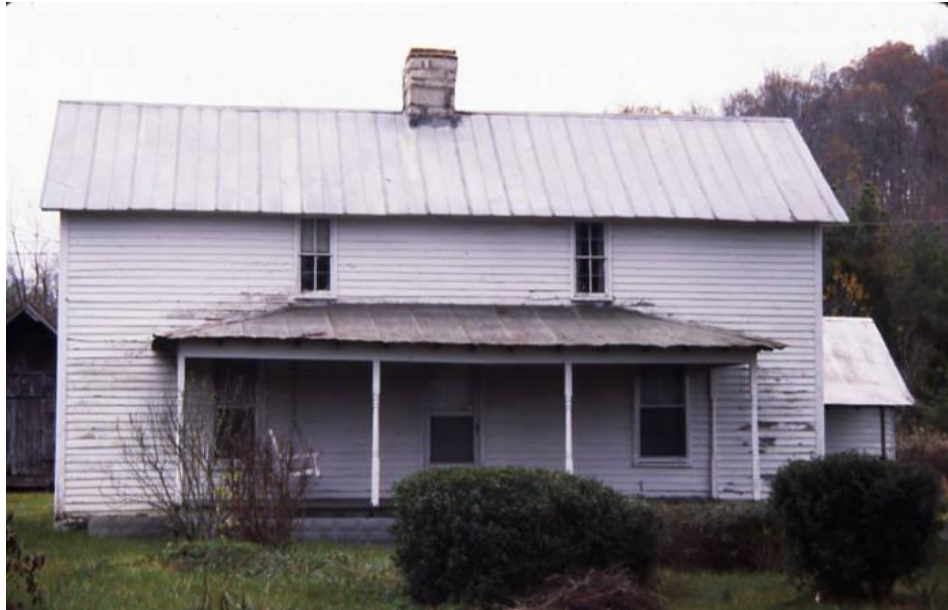
Figure 16. Circa 1990's picture of the Gardner Homestead. Photo provided by the Center for Historic Preservation.

One of the important architectural features of the main house is the central chimney. The central chimney can be seen from a photo taken of the home in 1995 before the chimney fell over. Now, most of the chimney is hidden underneath the metal roof, and at some point, it should be rebuilt.

The central chimney should be rebuilt as a defining feature of the home's architectural style. This chimney does not have to be functional, but it is a matter that the family and board will need to discuss. If the chimney is not rebuilt, the ridge cap where the chimney was located needs to be replaced. When working on the chimney, the flue must be inspected for safety. If the flue does not meet safety regulations, it needs to be repaired; documenting what it looks like is crucial so that the repairs can be accurate.

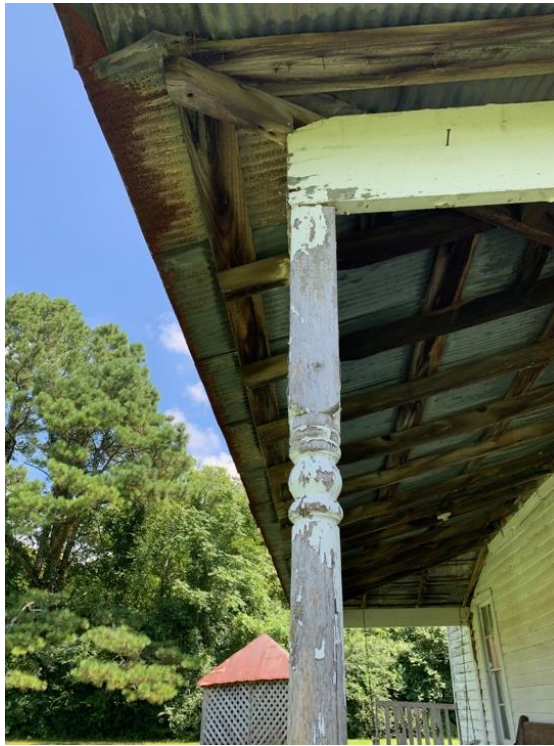
Figure 17. Turned spindles on the front porch. Photo provided by Kate Hughes.

On the facade of the house, floor has three bays with a central entrance flanked by double-hung windows. The second floor only has two symmetrical windows on either side of the entrance. The east and west sides of the home have one window on the first and second floors. There are no windows on the back of the main house, but a back door leads from both first-floor rooms. Matt Gardner built a front porch and back porch on the main house. The supports for the front porch are turned spindles, while the supports on the back porch are rough-hewn. The back porch spans the length of the house and connects the main house to the kitchen and dining room. The porch was extended to reach past the home to the end of the dining room.

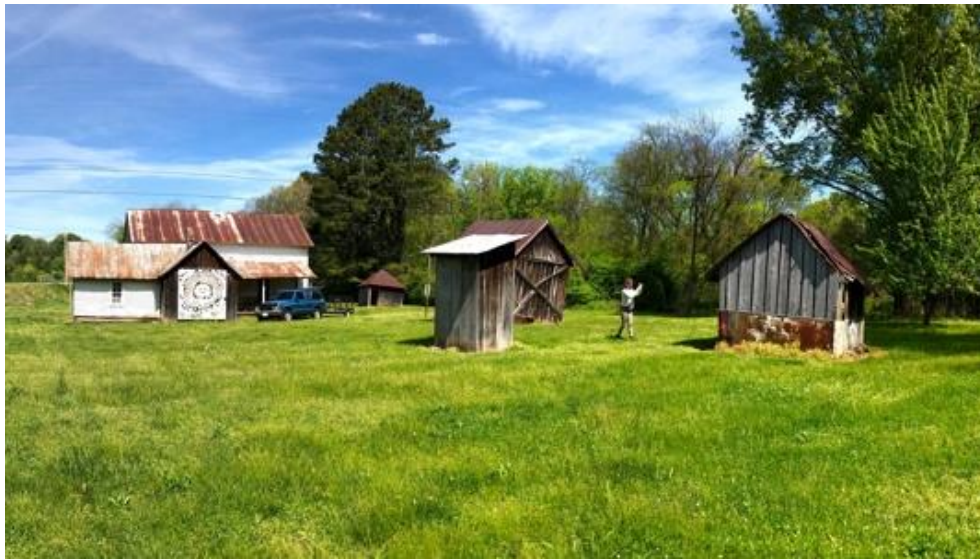
Figure 18. Gardner Homestead outbuildings. Photo provided by Abigail Coomes.

The outbuildings also have significant architectural features. The chicken coop is substantial because it is a larger coop design, and most of the original features remain inside. The privy was built during the depression era by the Works Progress Administration's sanitation facility program. Though the horse barn is collapsing, its size is a testament to the wealth and status that Matt and Henrietta had. Matt and those who helped him build the house and outbuildings were most likely never formally trained in

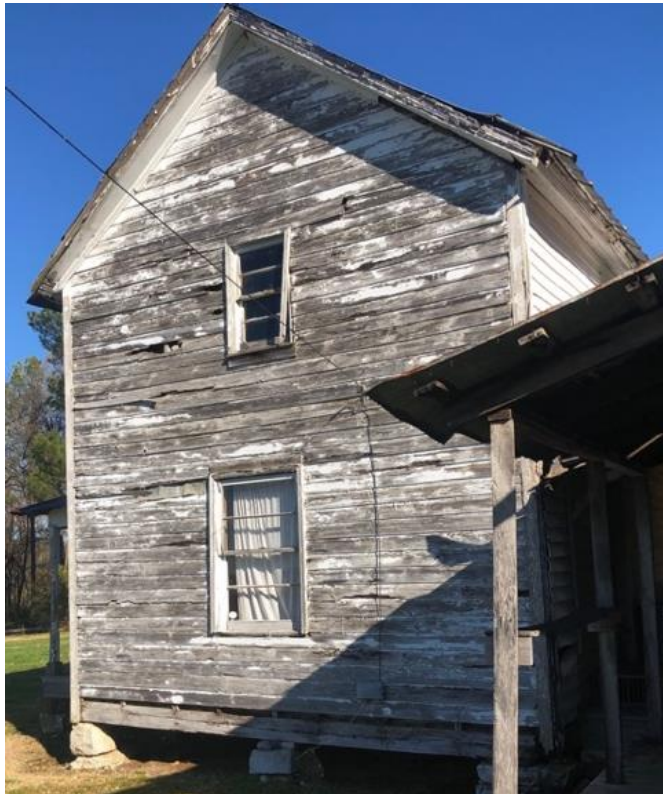
Figure 19. West side of the main house. Photo provided by Abigail Coomes.

The house's limestone foundation should be assessed. There are no visible foundation issues but having an assessment will ensure the home can handle the traffic and weight of being reopened to the public. The metal panels along the foundation should be repaired so to block access to the underside of the house to any animals; a door can be added to allow access when needed. Water damage is the biggest threat to the home's foundation; one way to stop this is by adding a six-mil sheet of plastic under the home to act as a water vapor barrier. Another way to mitigate future foundation issues is installing French drains on the house. French drains are essential because they move water away from home, allowing for proper drainage. Removing any landscaping away from the house's foundation will also help adequate drainage. Overgrown landscaping too close to the home should be removed.

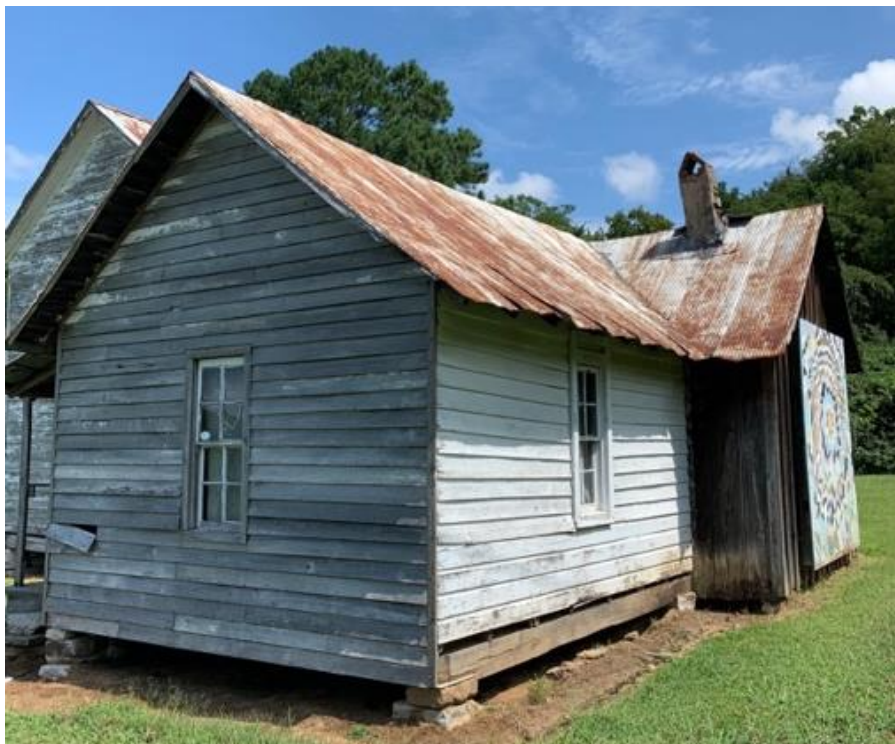
Figure 20. West side of the kitchen. Photo provided by Abigail Coomes.

The weatherboard on the north wall has a small hole near the corner board connecting the north and east walls of the house. Any damaged or missing battens or corner boards should be replaced. Removing siding includes the tarpaper on the kitchen's exterior walls, which needs to be taken down and properly disposed of by professionals. A significant amount of siding along the south wall of the dining room needs to be replaced. Most of the damaged siding is along the bottom of the structure by the support beam for the buildings floor. Along the west side of the dining room, several pieces of siding are

The weatherboard needs repairs and/or replaced. All weatherboard sidings need to be checked for any damage caused by either water or bugs like termites—several places on the home's exterior where the siding needs special attention. There are several holes where the weatherboard has rotted away on the west side of the house. The most significant gap is near the top left side of the first-floor window. The opening allows water and bugs to get inside the house and can cause damage to the exterior and interior of the home. Above the support beam for the floor on the west side of the home, there is a small section of the weatherboard that is missing. The east exterior wall of the house has a hole in the weatherboard at the bottom near the support beam. There are no other visible holes on this wall, but there is visible damage to the rest of the weatherboard, including a warped board that is below the second-story window toward the façade.

The windows and exterior door frames need to either be repaired or replaced. The second-story window on the west side of the home has part of the window frame coming to lose. Window frames need to be checked for rot and ensure no loose frame pieces. Any windows that need work should be replaced with period windows and trim. The glass on the windows also should be looked over for any cracks or any loose glass panels. The windows should also be checked to ensure they are correctly sealed to keep the elements and other critters out; adding flashing above the windows is recommended. The flashing is also recommended over the exterior doors and door frames.

The door frames need to be replaced or repaired if any rot or lose pieces are found. The kitchen board and batten door need the hinges replaced; if other doors present with these issues, they should be replaced as well. Any metal screen doors or metal window screens need to be removed. It is also recommended that any locks on the door be rebuilt or readjusted as required.

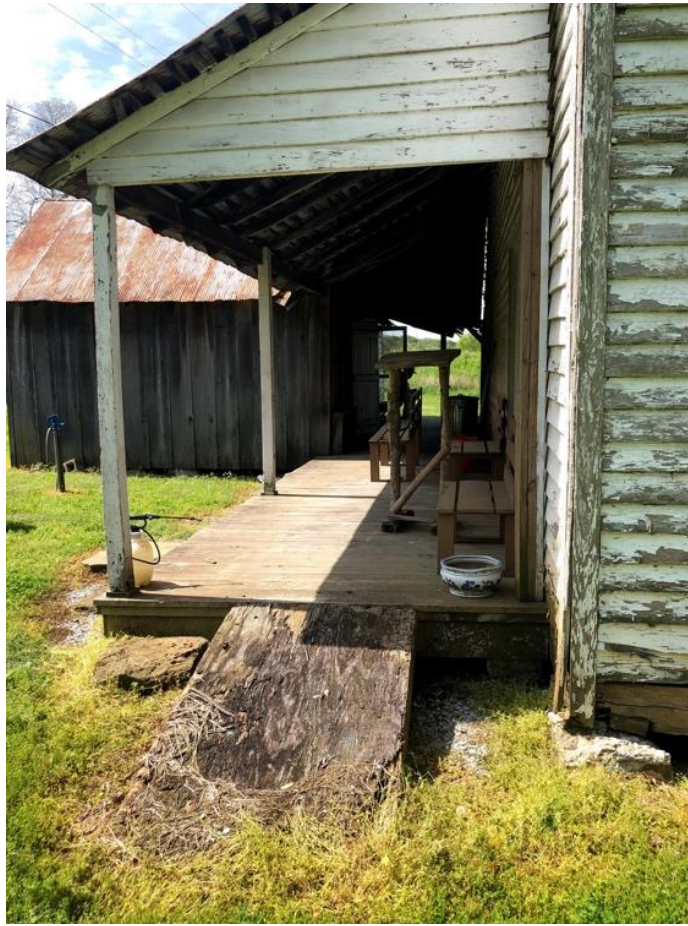
Figure 22. East side of the back porch. Photo provided by Abigail Coomes.

needs to be fixed as the gap will worsen, eventually to the point of being completely detached from the house and making the porch unsafe for the public to access. Both porches also need metal flashing added between the roof and the exterior wall to prevent water from getting between the wall and roof. The addition of flashing will also avoid any future problems with the porch roof separating from the house.

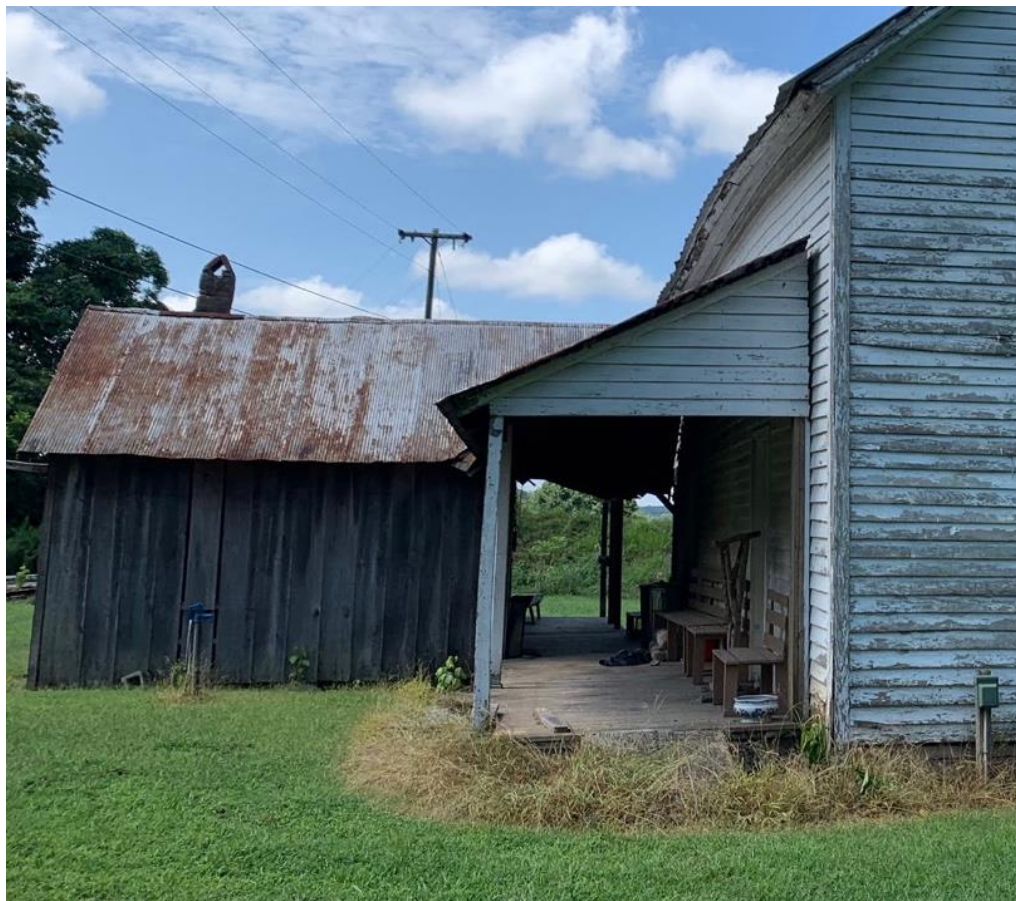
Figure 23. East side of the back porch with vegetation around ramp. Photo provided by Abigail Coomes.

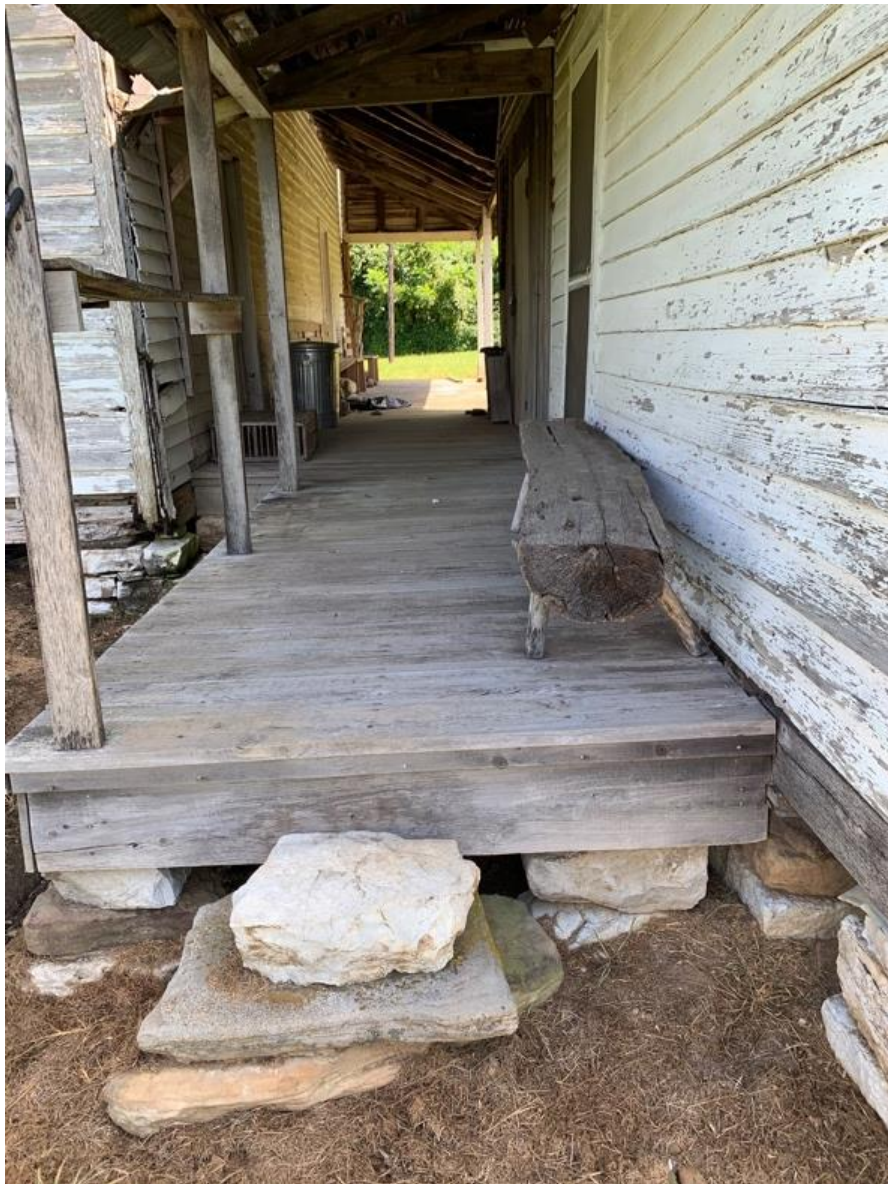
Figure 24. West side of the back porch with stone steps. Photo provided by Abigail Coomes.

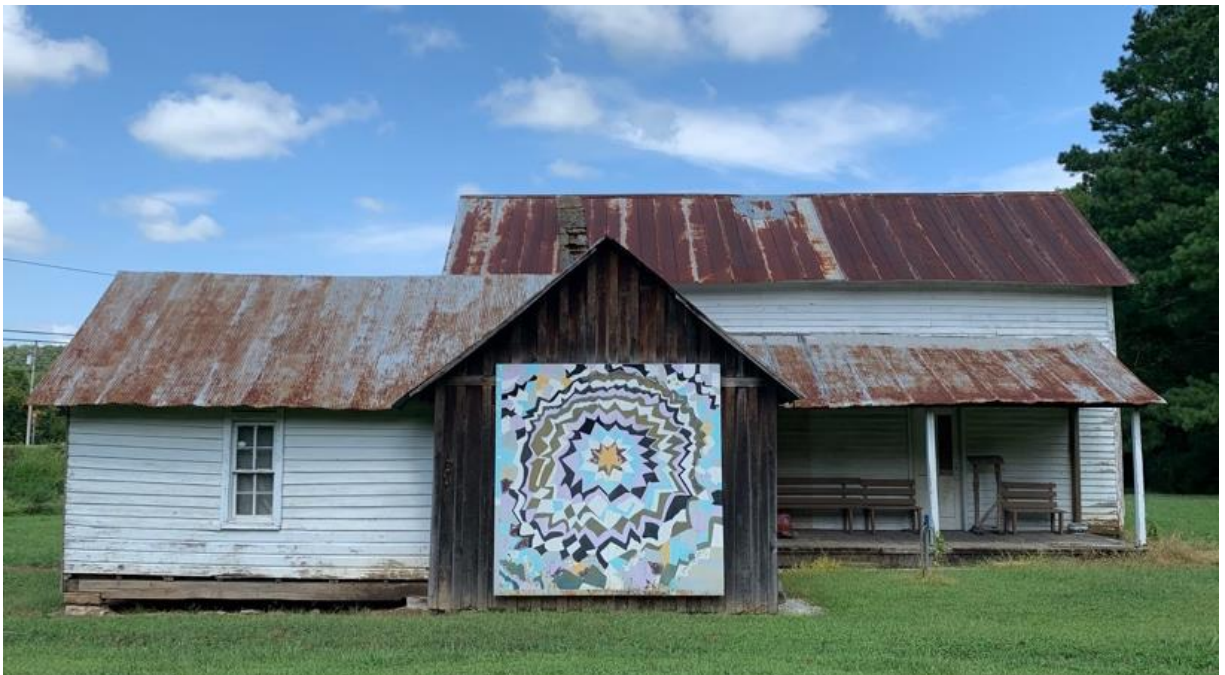
Figure 25. South side of the main house and kitchen addition. Photo provided by Abigail Coomes.

It is recommended that professional roofers assess the extent of rust on the metal roof and to check for any holes as a result of severe rusting. Identifying the location of holes in the metal roof will help when addressing the issue of water damage in the interior of the house. Depending on the state of the metal roof, it will either need to be replaced or repaired; this applies to the main home, porches, and the kitchen and dining room. If the roof needs to be repaired, several loose sheet panels will need to be screwed back into place. After the metal roof is replaced or repaired, it would be recommended to paint it with a reflecting roof paint. The fly rafters and roof board eaves on the main house, along with the kitchen and dining rooms, need to be either replaced or repaired.

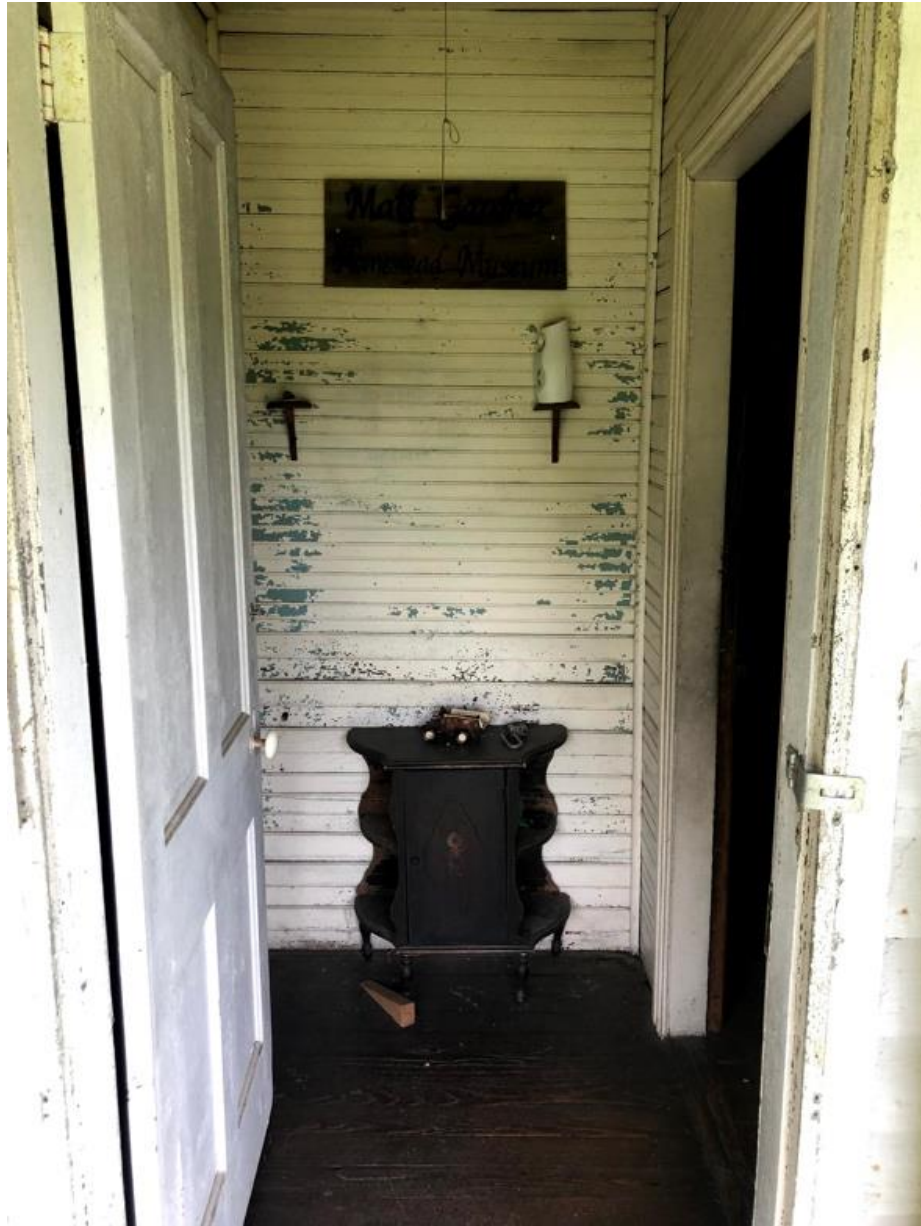
Figure 26. Main entry to the house on the north side of the building. Photo provided by Abigail Coomes.

The alcove/entryway is painted white, but a teal or green color is visible where the white paint has chipped off. The correct paint color needs to be determined. Other areas where the paint has worn away indicate no other paint on some paneling. Depending on the results, the room needs to be prepped and repainted with white or teal color. The base molding on the first floor has original molding and more modern molding. Modern molding needs to be removed and replaced with molding that matches the period molding. The door frames and interior doors need to be inspected for any issues with the hinges, frames, locks, or handles. The ceiling in the first-floor bedroom is painted white and should be determined if this color was correct to the period of significance.

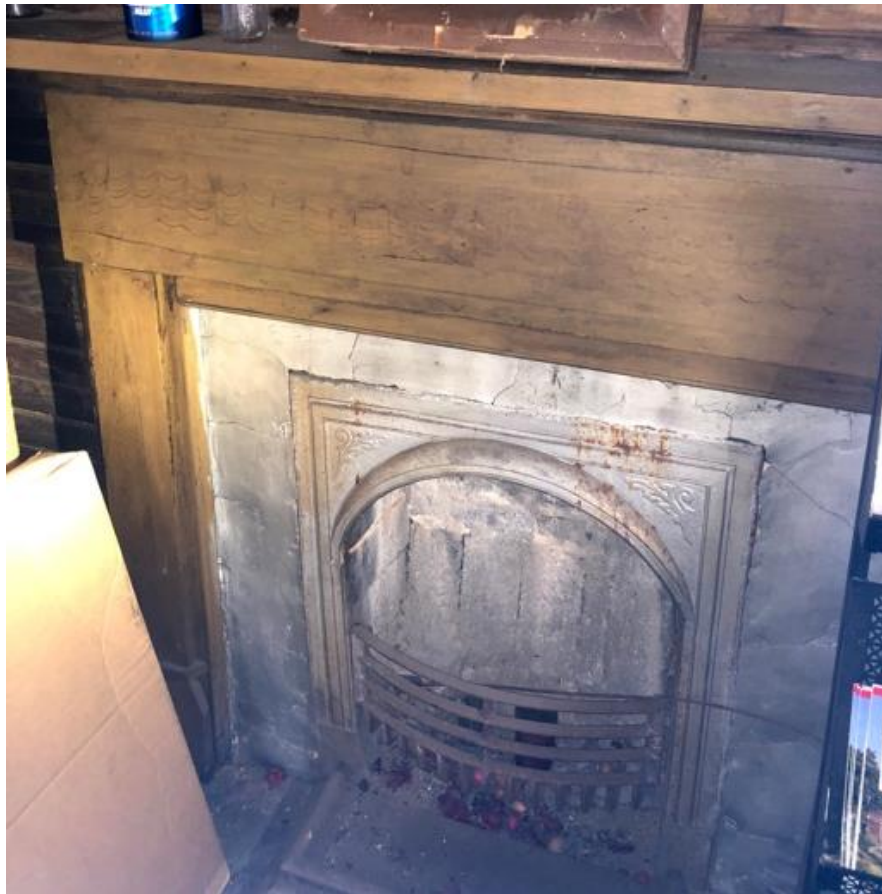
Figure 28. Fireplace in the East first-floor parlor. Photo provided by Abigail Coomes.

With the chimney being an important exterior feature of the home, the double fireplaces in the interior are equally as important. The mantel in the parlor is original, and marks from woodworking tools can be seen in the wood. The parlor mantel needs to be washed with Murphy's Oil Soap and water. The fireplace in the first-floor bedroom is missing the mantle. There is a temporary one over the fireplace that needs to be reassessed. If possible, a period mantel should be acquired and installed, or a replica of the parlor mantle could be crafted by a woodworker. Both fireplaces have cast-iron inserts, and these need to be cleaned and cleared of debris. If the chimney is not rebuilt, the flues of the fireplaces will need to be adequately sealed so no animals or birds can get inside the home.

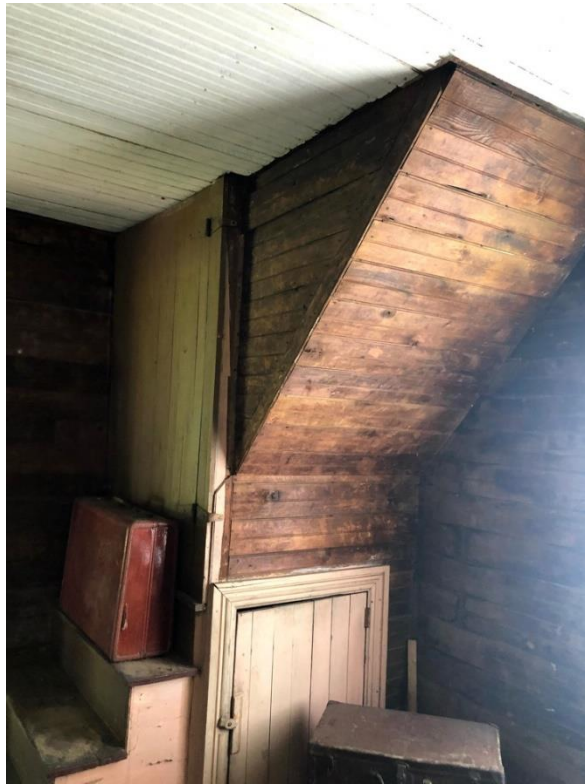
Figure 29. Box staircase in west side first-floor bedroom. Photo provided by Abigail Coomes.

The biggest interior project outside of the fireplaces will be stabilizing and repairing the box stairway to the second floor. The stairway is in the righthand corner of the west bedroom. Three steps are not enclosed and lead up to a door where the box stairway starts. The stairway will need to be inspected for any damaged boards that might impact the structural integrity of the stairs. The wall to the south of the staircase has two gaps in the wood where it has rotted away. Wallpaper covers most of the walls in the stairwell and needs to be assessed. Removing the wallpaper may reveal if the wood underneath needs to be repaired. A small portion of the wallpaper could be preserved under plexiglass to show how the home has changed over time, or it could be removed, and a small section framed.

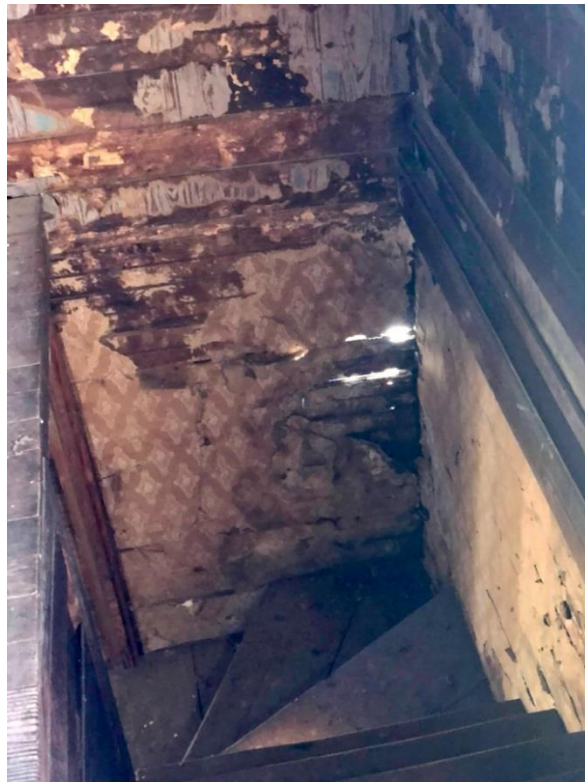
Figure 30. Inside the box staircase from the second-floor. Photo provided by Abigail Coomes.

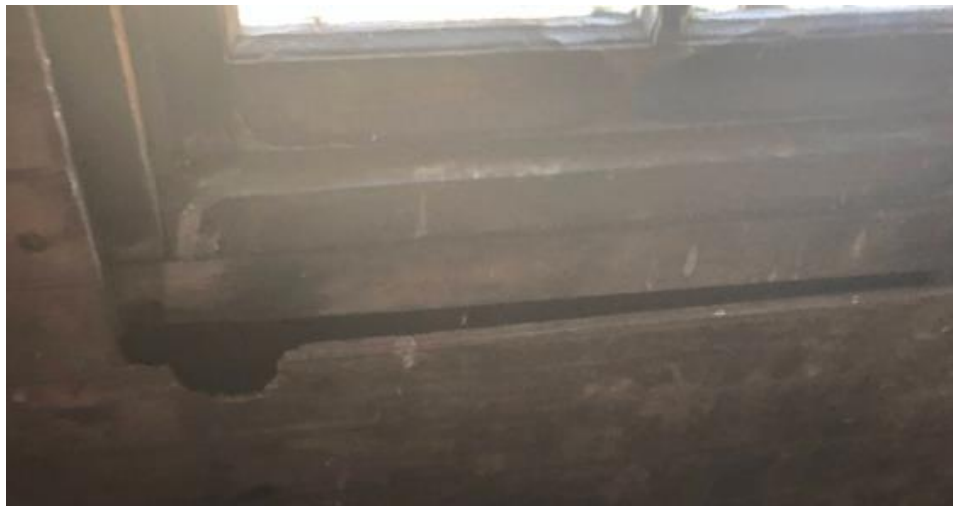
Figure 31. Gap under window in the west second-floor bedroom on the west wall. Photo provided by Abigail Coomes.

In the west bedroom, there are gaps in the west wall that will need to be filled in, or the boards and paneling be replaced. On this wall, the window is also loose in its frame, and a gap has formed in the paneling. Another concern along the bottom of the north wall towards the west end of the room. A section of the paneling is warped to the point of creating a gap to the outside at the floor line.

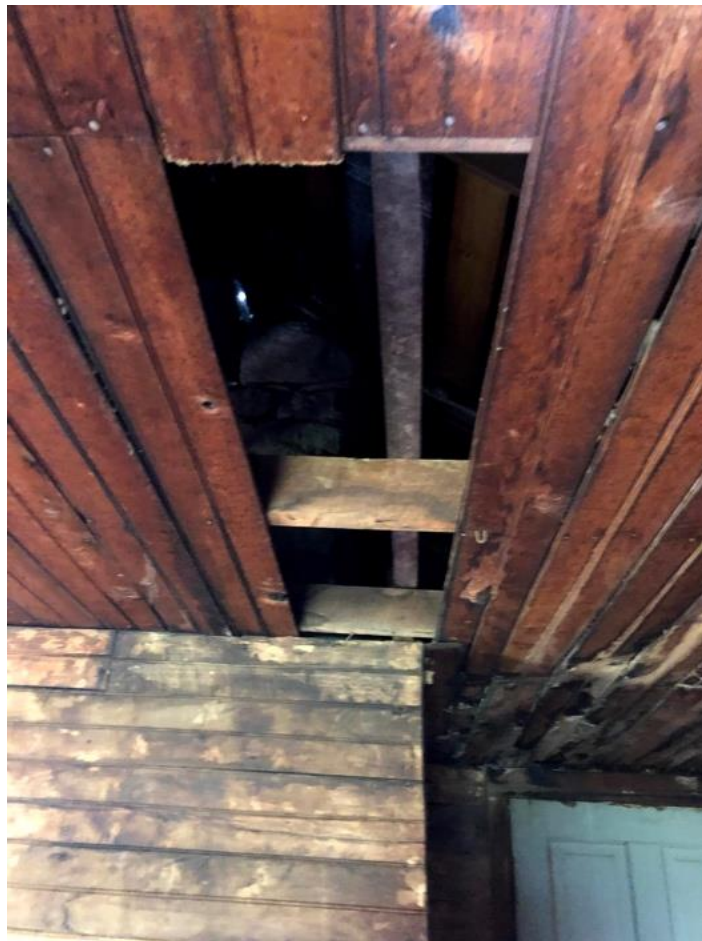
Figure 33. Missing panels in the ceiling of the west second-floor bedroom. Photo provided by Abigail Coomes.

The ceiling in both second-floor bedrooms is a primary concern. Both bedrooms there are sections missing; the boards need to be replaced to seal off access to animals, birds, and the elements. The chimney can be seen through the hole in the east bedroom 's ceiling, and the rafters can be seen through both holes.

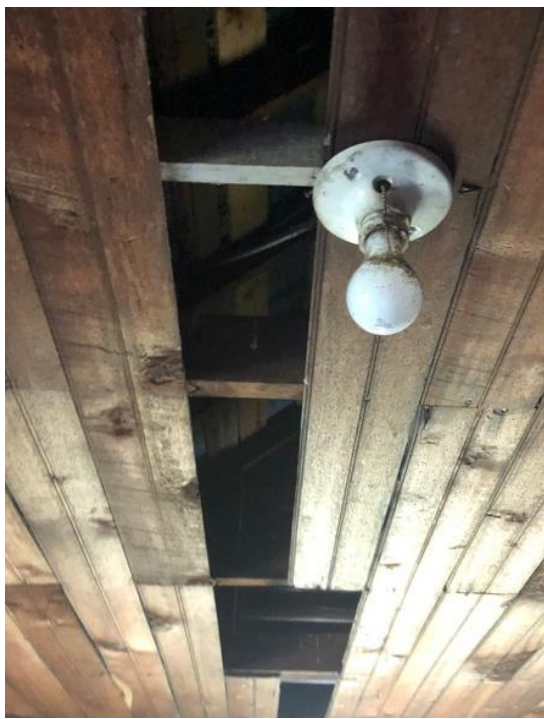
Figure 34. Missing panels in the ceiling of the east second-floor bedroom. Photo provided by Abigail Coomes.

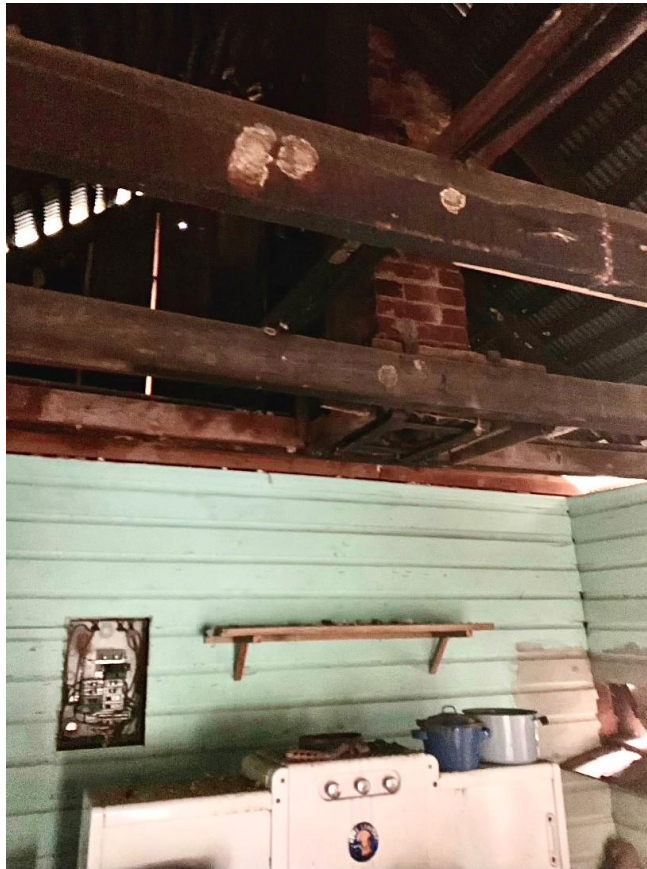
Figure 36. View of the chimney through and roof in the kitchen. Photo provided by Kate Hughes.

Artifacts in the kitchen and dining room addition, c. 1920 will also need to be cleaned and removed before the restoration process. The ceiling in the kitchen was sheetrock at some point but was taken down, leaving the rafters, roof and chimney exposed. If left in its current state, the remainder of the chimney should be inspected for structural damage. Two considerations are if the rafters continue to support the chimney and how stable is the section above the roof. If the chimney is removed, this change may require more work on the kitchen's roof. Installing a new ceiling will need to be done in

the kitchen; this could also be affected by the chimney. The kitchen is currently painted a mint/teal color; it would be recommended to see if the color was original to the room. If not, the paint should be stripped, and the wood refinished. Should the paint be authentic, the kitchen needs to be prepped, and a new coat of paint would be recommended.

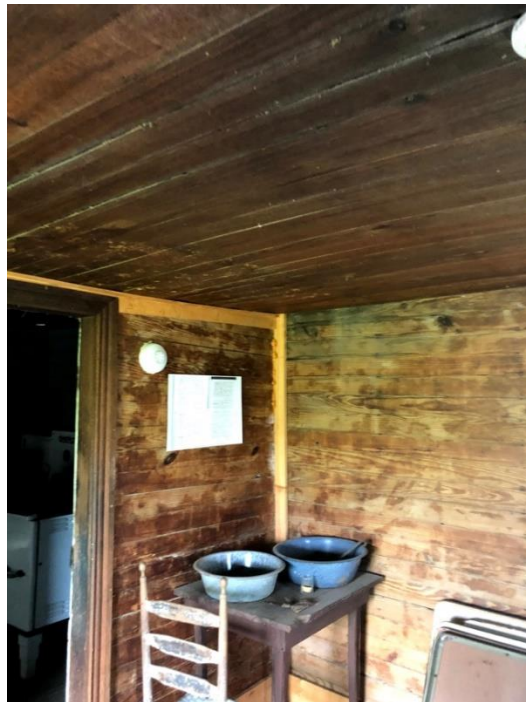
The ceiling in the dining room has some warping in the boards, probably due to water damage and/or humidity. A few panels in the dining room have already been replaced, and they need to be stained to match the rest of the wood in the room. The trim, window frames, and door frames should be checked for loose or damaged sections.

Figure 37. View of the ceiling and walls of the dining room. Photo provided by Abigail Coomes.

The hardware on the doors for the kitchen and dining room needs to have proper period pieces installed that match the rest of the home's hardware. Electricians should check the electricity in the two rooms to ensure it is up to code. Floors should be inspected for needed repairs.

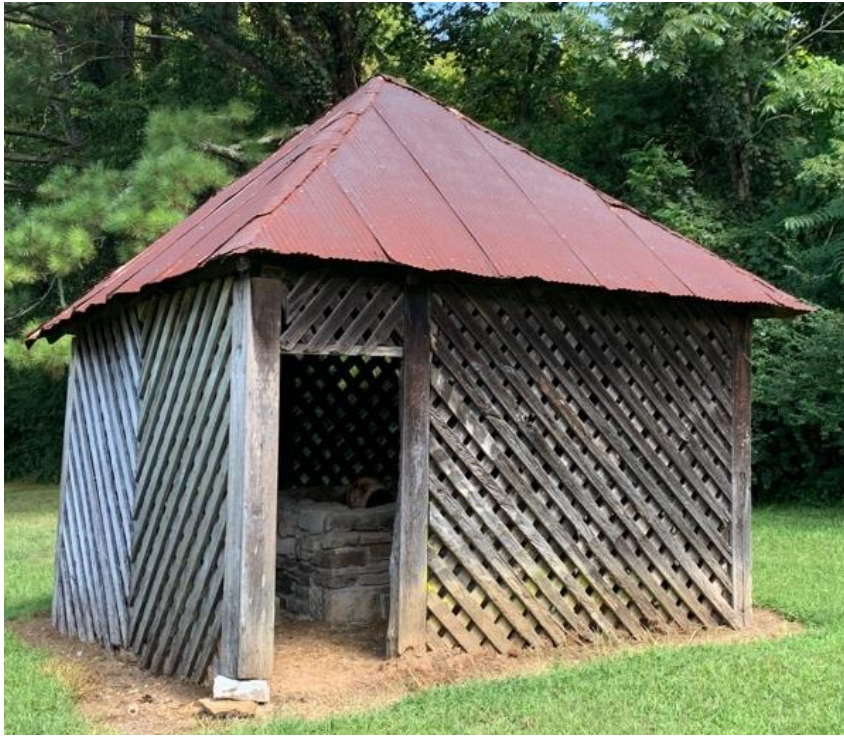
The well house was initially constructed c. 1870 with a circa 1930's metal roof. The walls are wood latticework that has been replaced once due to termite damage. There was also a limestone foundation, but only a few stones remained. The main concern with preserving this building is to keep it structurally sound and free of termite damage. Any repairs or replacements for the metal roof should be carried out. Also check for loose stones in the well. A mason should repair the stonework, if necessary, iron bars have been placed over the well to ensure it is inaccessible to people. These bars need to be secured.

Figure 38. Exterior of the well house. Photo provided by Abigail Coomes.

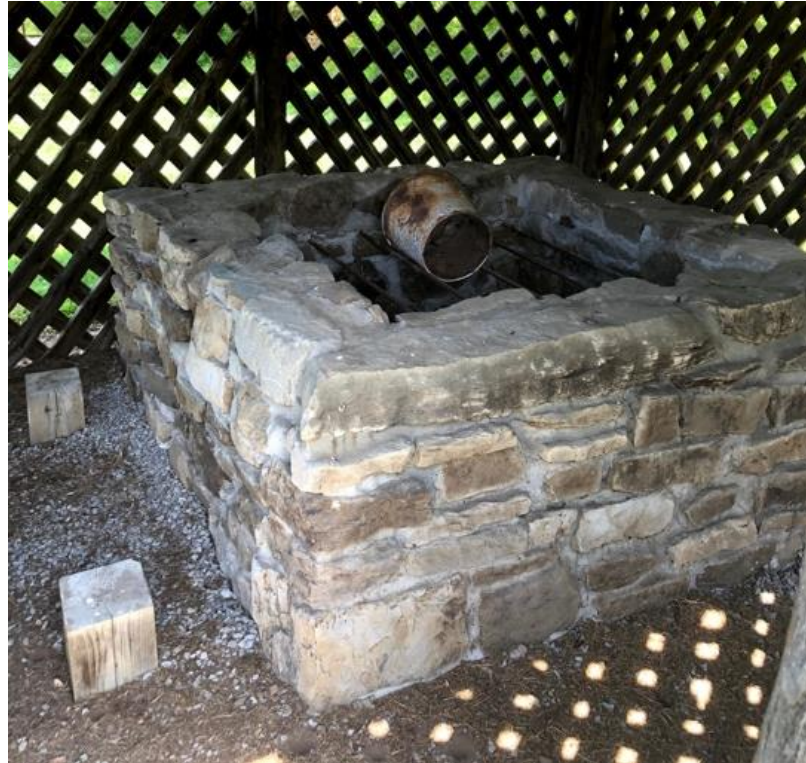
Figure 39. Interior of the well house. Photo provided by Abigail Coomes.

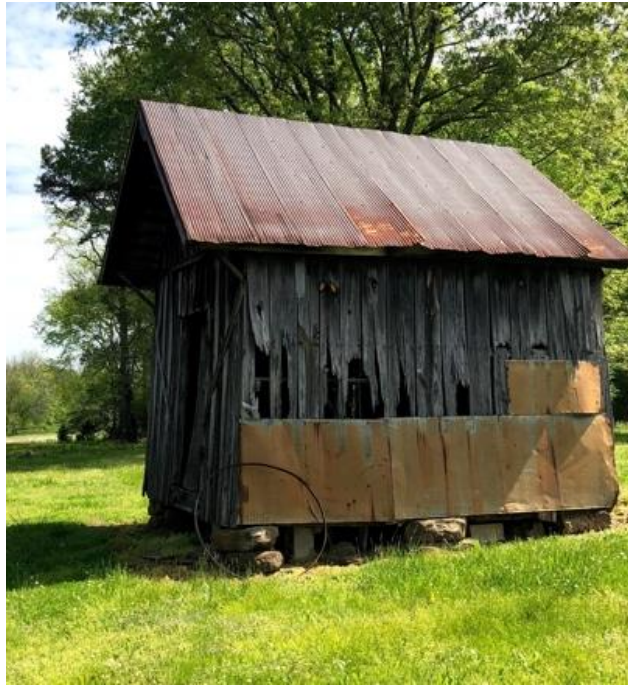
The chicken coop, circa 1925, is an important structure on the property as it is one of the last livestock buildings left standing. Metal sheets have been placed around the outside of the coop where there are missing boards. These pieces of sheet metal need to be removed as they are not original to the coop's design. Once the sheet metal is removed, any damaged boards should be replaced. Any debris inside the chicken coop needs to be removed and the interior cleaned. Most roosting bars are still inside the coop and should remain there. If any are rotten or damaged, then they need to be replaced. The original nesting boxes are also still along the bottom of the coop. The coop's east wall is where the door and chicken gate are located. The hardware on both the door and gate needs to be replaced with a period-appropriate piece if the current ones are too rusted. The roof on the southwest side of the coop needs replacement; the entire roof and the limestone foundation of the coop should also be inspected.

Figure 40. Exterior of the chicken coop. Photo provided by Abigail Coomes.

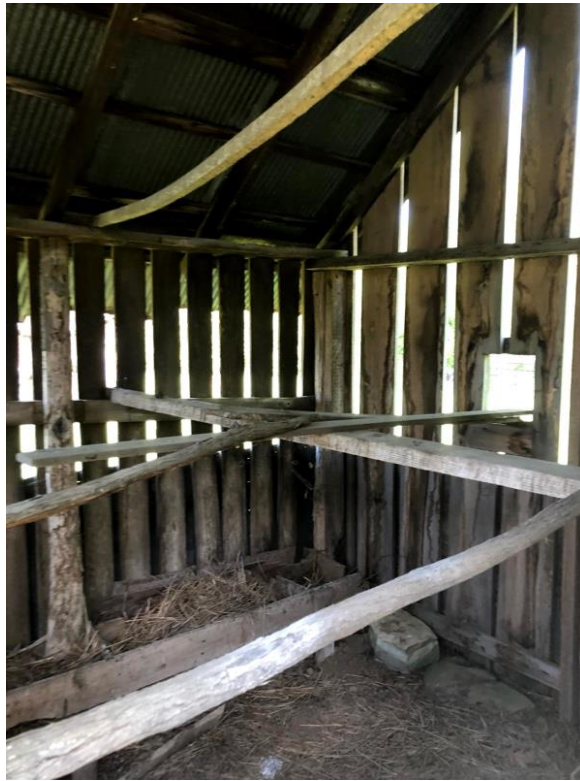
Figure 41. Interior of the chicken coop. Photo provided by Abigail Coomes.

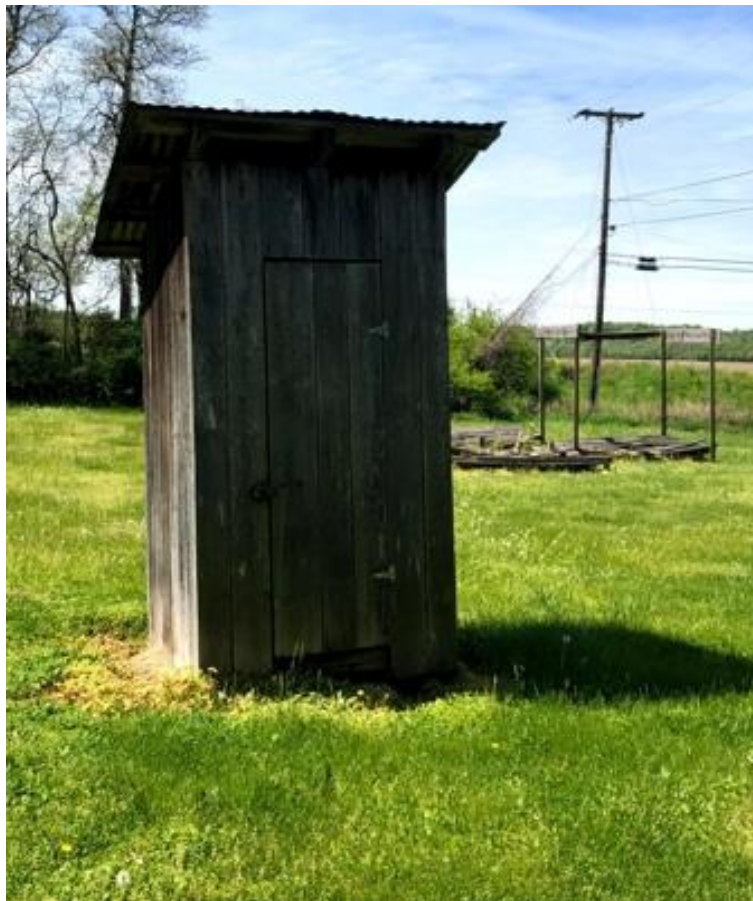
The privy was built in 1936 as part of the Works Progress Administration program for better sanitary facilities in rural areas. No visible issues can be seen on the foundation of the privy but still should be assessed for any possible problems. The boards around the building also seem to be in good condition, along with the metal roof. Any damage or debris on the inside of the privy needs to be fixed and removed. Lastly, the hardware on the door should be replaced or repaired as needed.

Figure 42. Exterior of the privy. Photo provided by Abigail Coomes.

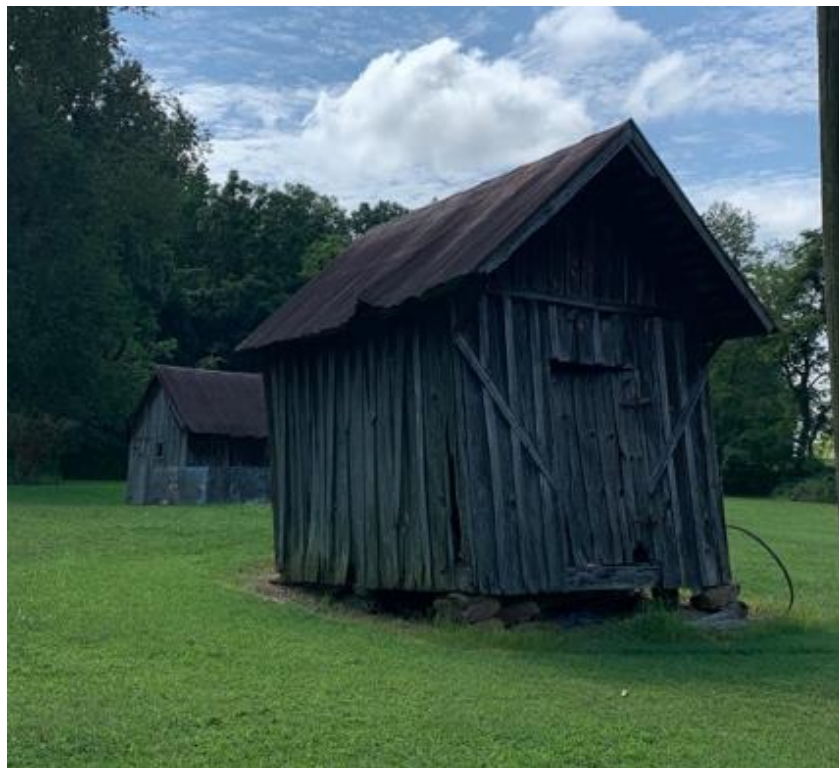
The smokehouse/store was built along with the main house in 1896. Unfortunately, due to a severe windstorm in December of 2021, the smokehouse collapsed. The debris from the building's collapse needs to be removed from the property. As of the December 2021 visit to the property Gary Gardner, the property's caretaker stated that he would use the wood from the storehouse on a barn built by one of Matt and Henrietta's sons. If there is any wood remaining, it could help restore the walls on the chicken coop. Since this building was also the storehouse, it is recommended that the limestone foundation be left to show where the building was located.

Figure 43. Exterior of the smokehouse before December 2021. Photo provided by Abigail Coomes.

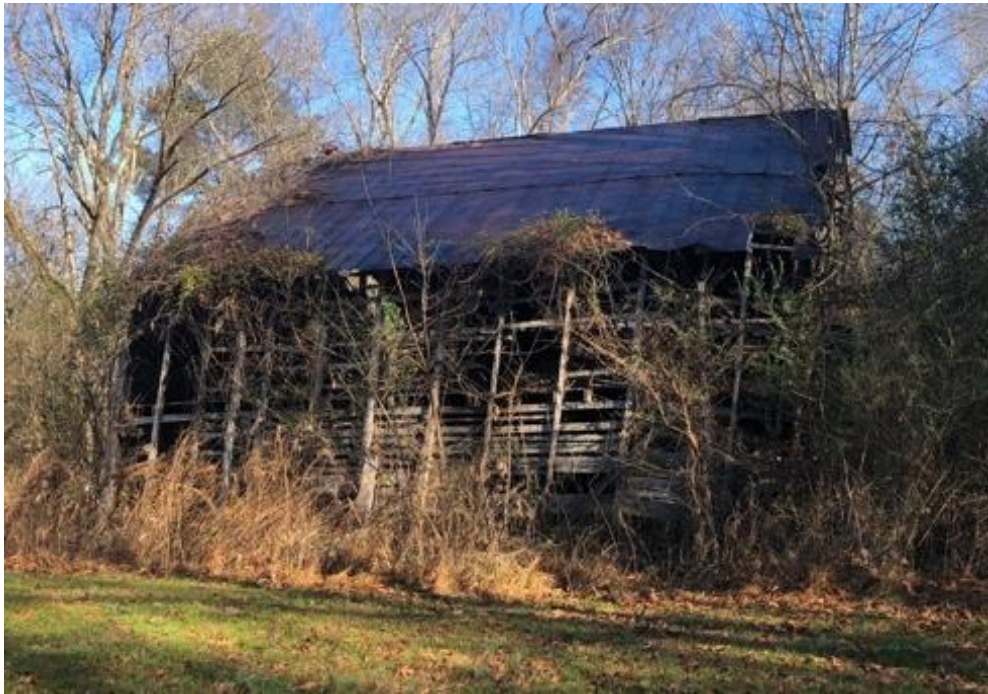
Figure 44. The west side of the horse barn. Photo provided by Abigail Coomes.

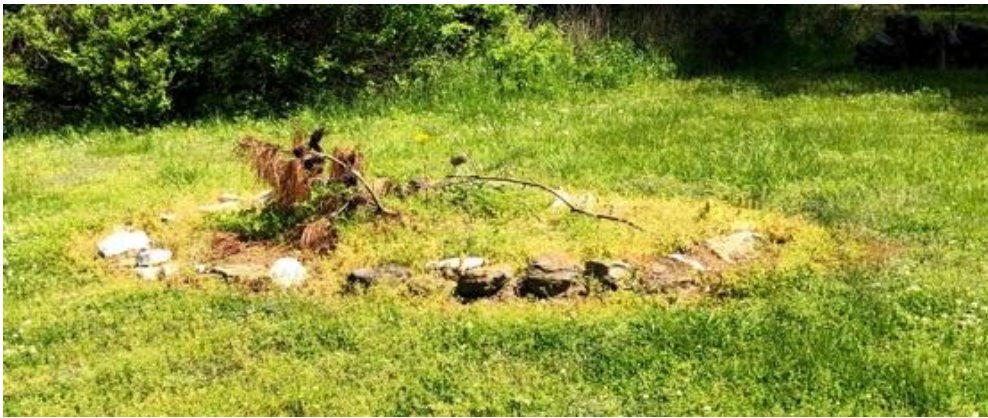
There is a ring of stones located behind the well house. This circle of stones could be a fire pit but more prominent than most. Another possibility is that this circle of stones could be the location of the sorghum press. It would be an ideal location because it was located near the well and the horse barn. More research will determine if this location was for the sorghum press.

Figure 45. Possible location of the Sorghum Mill. Photo provided by Abigail Coomes.
